**SciSite Corrosion Probe
Revolutionizing Rust Detection**

**Corrosion Probe Survey
M6 Bay 14/1 - 13/8**

This survey is of: M6 bay 14/1-13/8 (Northbound beyond junction 9)

Project Title: AREA 9 MAC MM467 MS RAY HALL VIADUCT

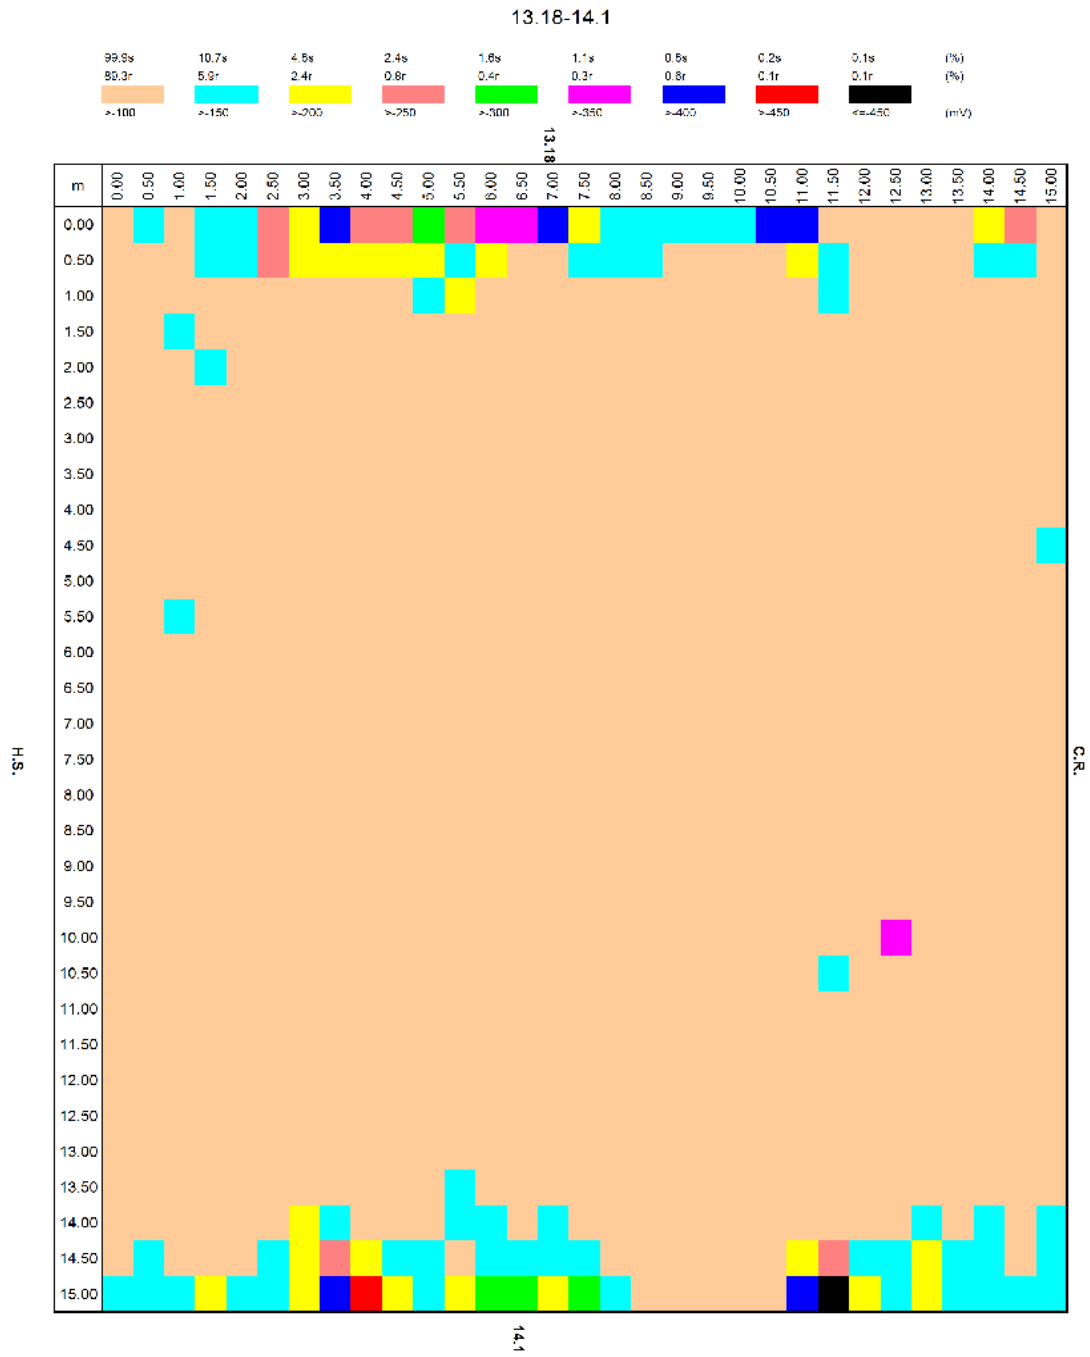
Half Cell Potential Map

At 15-17m along and 5-6m across the bay the corrosion map shows a large patch of corrosion. This does not appear on the half cell potential map, but is shown on the bay diagram as an area of low or little concrete cover. In fact the concrete cover had been all but removed by the planing process, revealing steel bars at the surface. One limitation of the half cell potential test is that it cannot detect the onset of corrosion without good electrical conductivity through a layer of concrete.

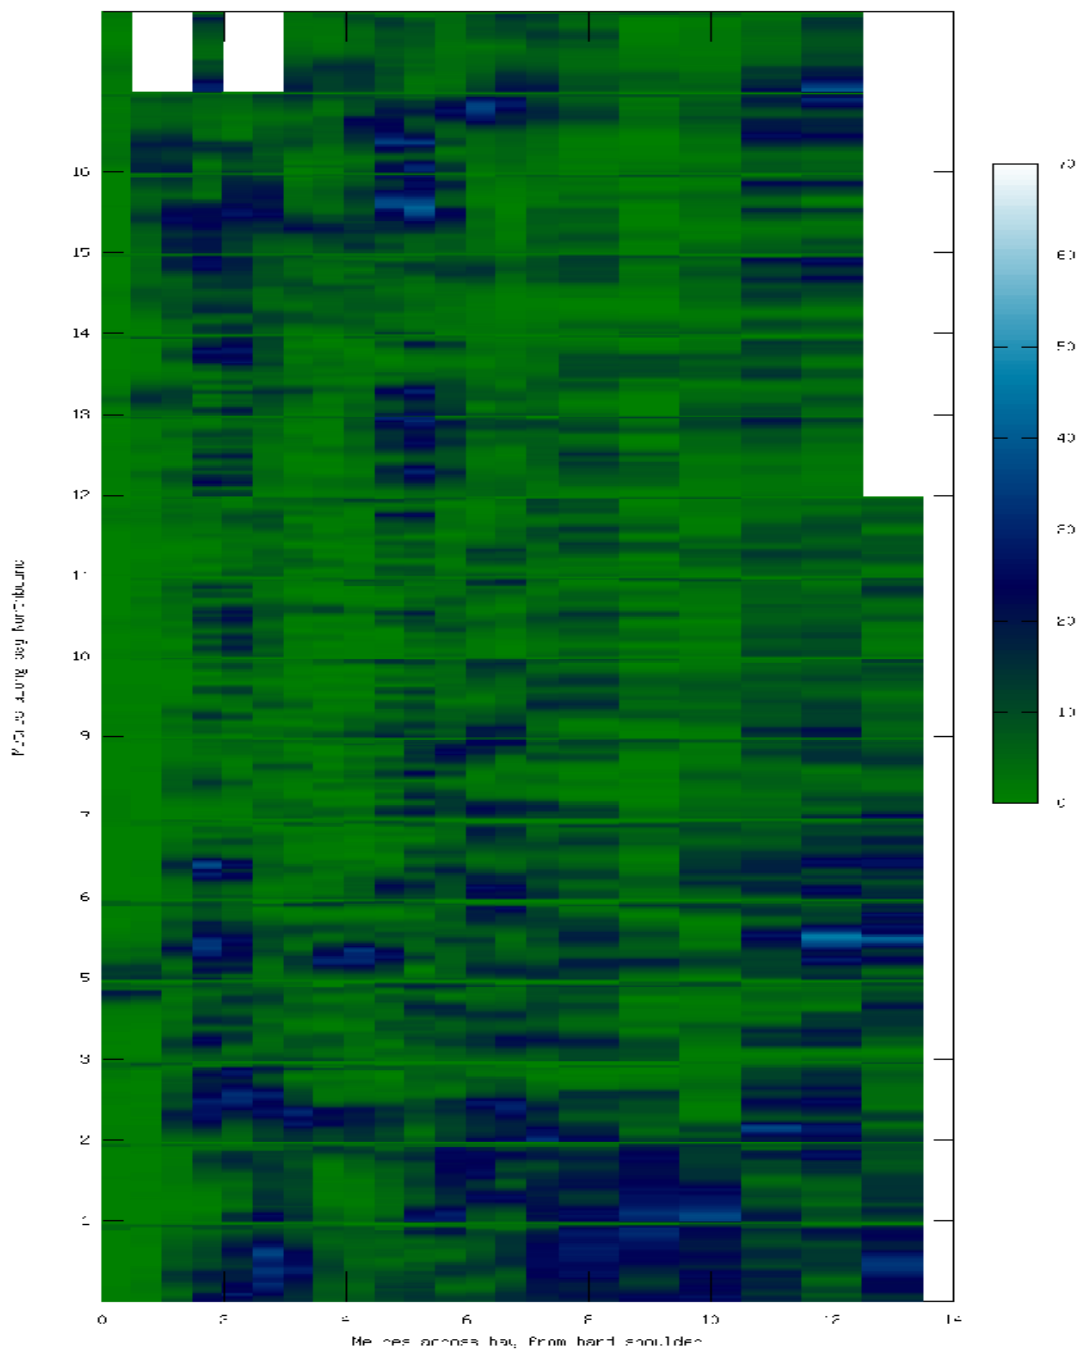
The data analysis of the corrosion probe signal produces a false colour map of the area surveyed. The areas that indicate rust are the peaks of the colour scale (blue to white). Shades of green indicate the noise in the data or very small signals which do not indicate rust.

The corroded areas start at the bay edges and extend up to 2 metres into the bay. The horizontal striping over all areas of the map indicates the presence of fine horizontal detail in the enclosed steel work. This indicates a steel mesh internal to the concrete.

There are horizontal features at the top and bottom edges of the bay which indicate the edges of the steel mesh in the bay, but which may reveal further information about rust on edge features.

Vertical features at 2, 5, 8, 11 metres across the bay are surface rust on the steel I-beams which are underneath – and support – the section of motorway deck. This demonstrates

that the technique is sensitive enough to detect surface rust at over 150mm distance.
